ADVANCED GAS TURBINE (AGT) TECHNOLOGY DEVELOPMENT

SEVENTH SEMIANNUAL PROGRESS REPORT (JANUARY 1983 — JUNE 1983)

Engineering Staff of
Garrett Turbine Engine Company
A Division of The Garrett Corporation

DECEMBER 1983

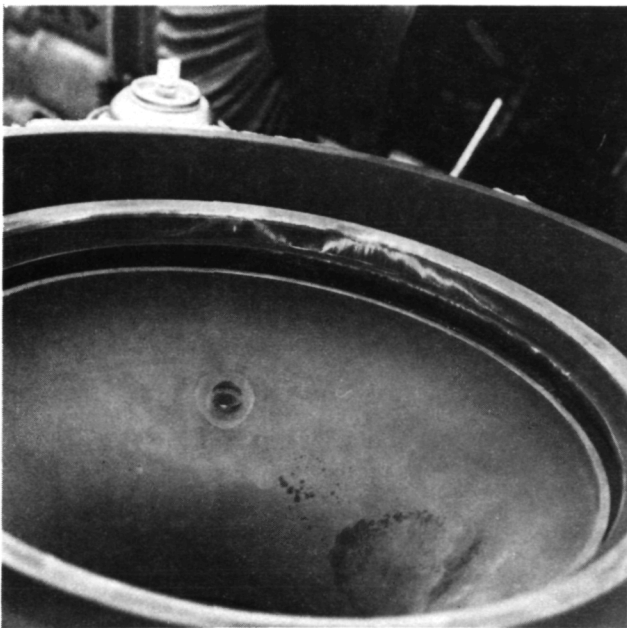
Figure 4. Fuller's Earth Traces - Flow Separator Housing/Transition Duct.

The engine was disassembled and inspected. The primary leakage path shown in Figure 3 was through the transition duct/turbine shroud/flow separator housing seal rings. Figure 4 shows Fuller's Earth leakage traces between the flow separator housing and the transition duct and in the flow toward the LP exhaust section. This same leakage is depicted in Figure 5 as it passes by the turbine shroud and out the LP exhaust. Figure 6 shows another leakage path by the exhaust housing sealing rings around the flow separator housing, and Figure 7 reveals the leakage around the regenerator seals (primarily at the corners of the diaphragms).

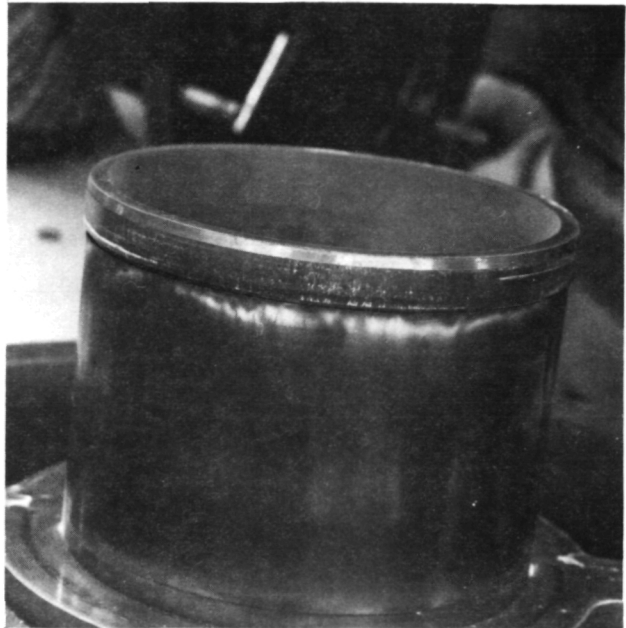
Figure 6. Fuller's Earth Traces - Regenerator Shield Piston Ring.

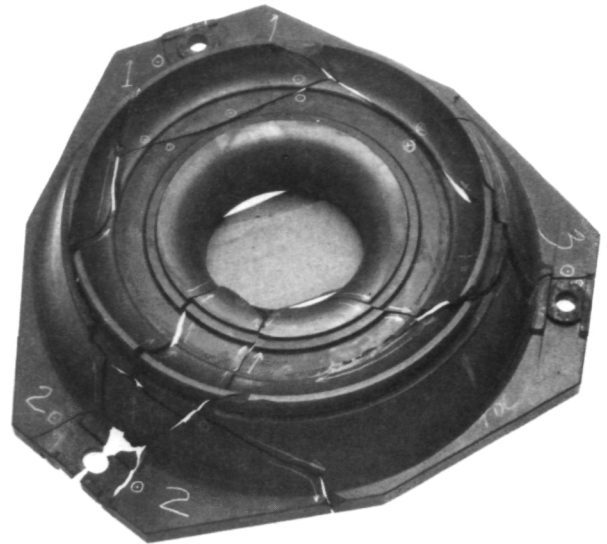
Figure 54. Turbine Shroud, S/N 180.

Component	Fracture Origin	Fracture Cause
Flow Separator Housing S/N 14	Forward Outer Diffuser and regenerator shield step	Mechanical loading, ie, high axial load
Turbine Shroud S/N 185	Bolt hole and rocker Slot fillet	Mechanical loading, ie, high axial load
Outer Diffuser S/N 244	Contact zone for eccentric spacer	Mechanical, ie, contact stress
Inner Diffuser S/N 173	Bolt holes	Mechanical at contact region, and thermal from bolt hole
Combustor Baffle S/N 219	Strut tip	Contact stress

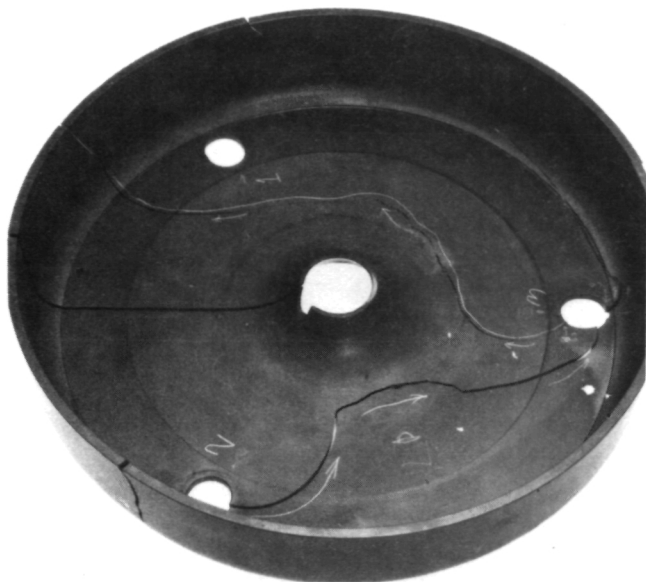
Figure 56. Inner Diffuser, S/N 173.
